**Subject: Final Removal Report for the TOCON Asbestos Removal Site
EPA Contract No. EP-S5-13-01
Technical Direction Document No. 0001/S05-0001-1607-008
Document Tracking No. 1409**

**FINAL REMOVAL REPORT
FOR THE
TOCON ASBESTOS REMOVAL SITE
GOSHEN, ELKHART COUNTY, INDIANA**

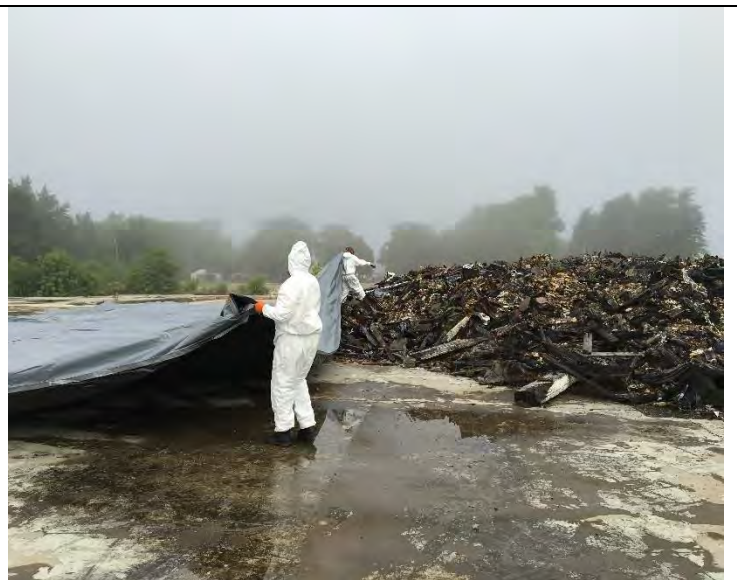
Photo: 7

Description: ER Contractor Wetting material down while prepping the Pile for load out

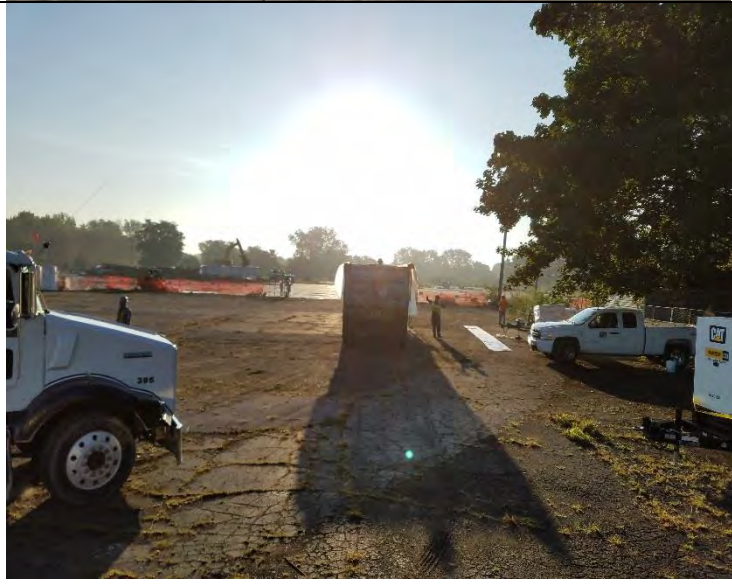
Photo: 13

Description: ER “burrito wrapping” the truck before leaving of site

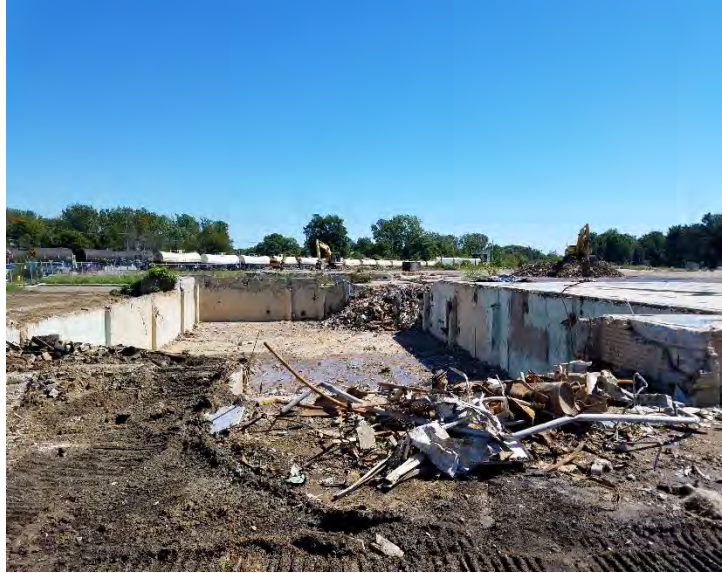
Photo: 28

Description: Foundation for Pile 1 has been completely abated and no longer has tile or mastic on its surface

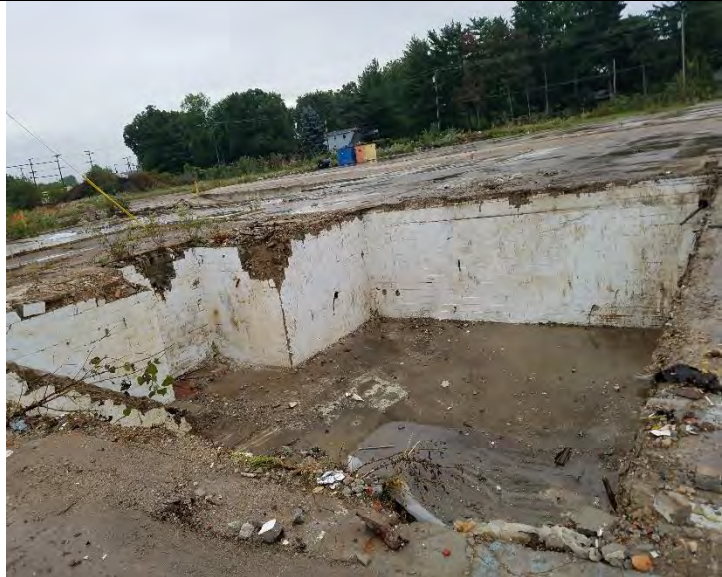
Photo: 34

Description: More Barrels were found in the large soil mound no evidence of leakage

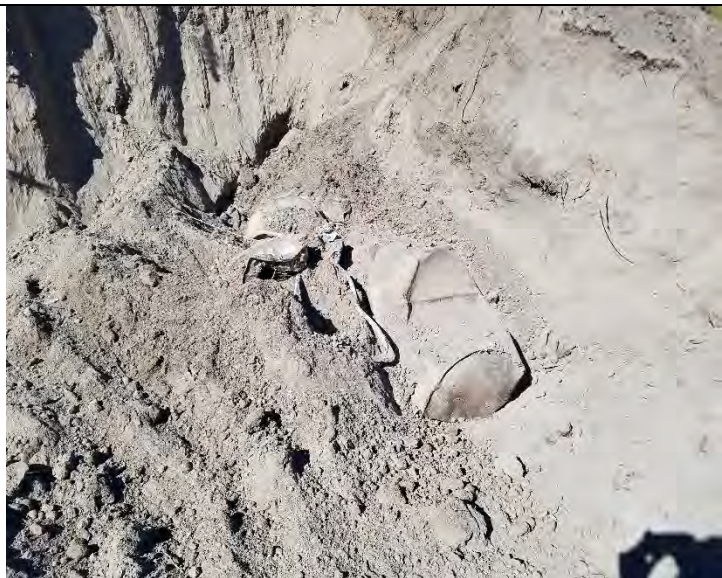
Photo: 35

Description: ER breaking through cement to get to the pipe chase
Photographer: Andre Baker

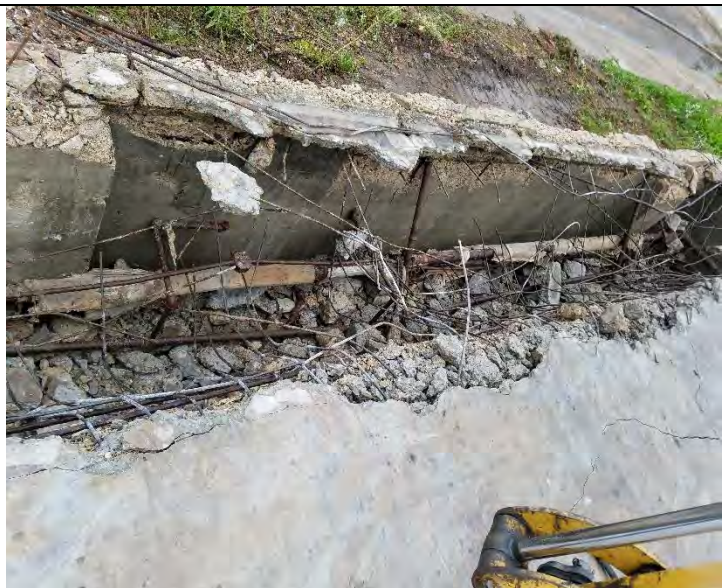
Photo: 37

Description: All sewer caps have poly and will be cemented shut

On September 22, 2016, a Goshen city storm water representative was on site and requested that ER use cement to seal sewer tops before the demobilizing from the site.

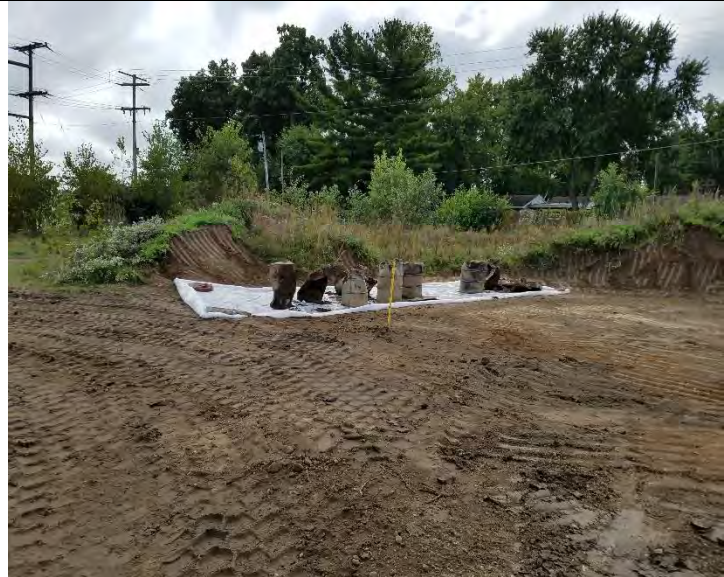
Photo: 40

Description: Mastic left over on the Pile 2 foundation and the ground by Pile two

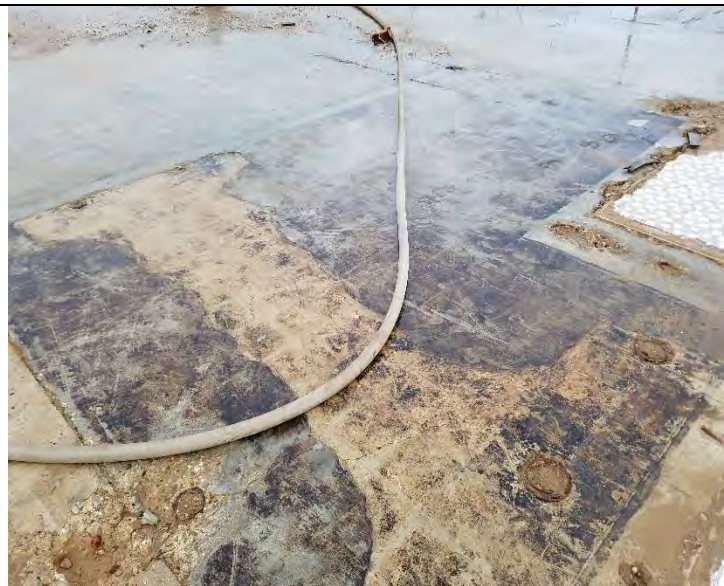
Photo: 41

Description: Mastic broken on top of slab Pile 2 and removed

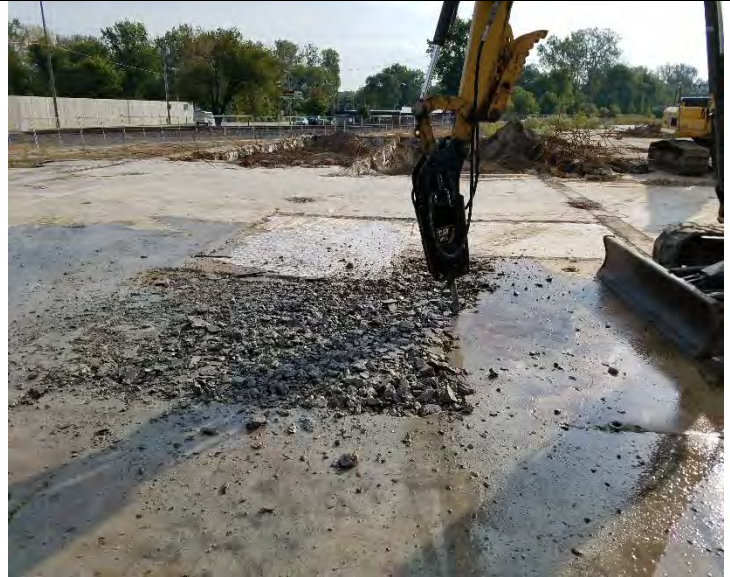
Photo: 42

Description: Mastic broken up on the floor next to Pile 2 and removed

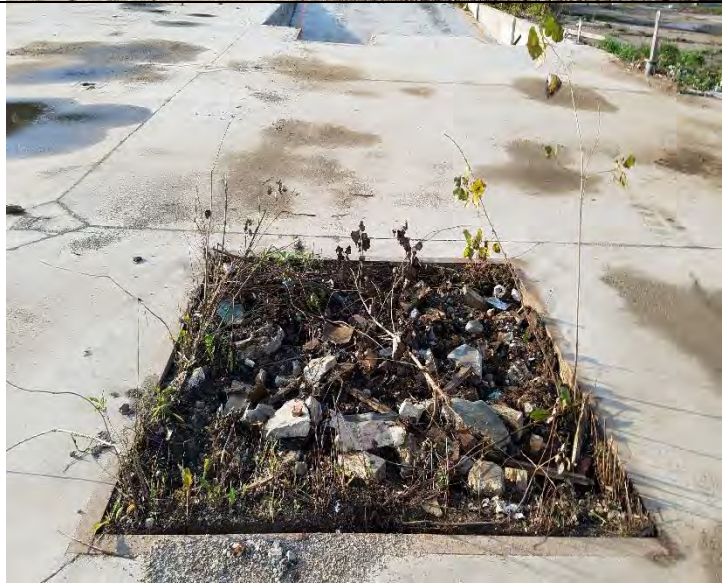
Photo: 47

Description: 5x5ft squares have had debris removed
